# INVERLOCH SURF BEACH EROSION REPORT

JUNE 2025

The following report contains an engineering assessment of the work required to obtain a satisfactory permanent solution to the erosion of the Inverloch Surf Beach.

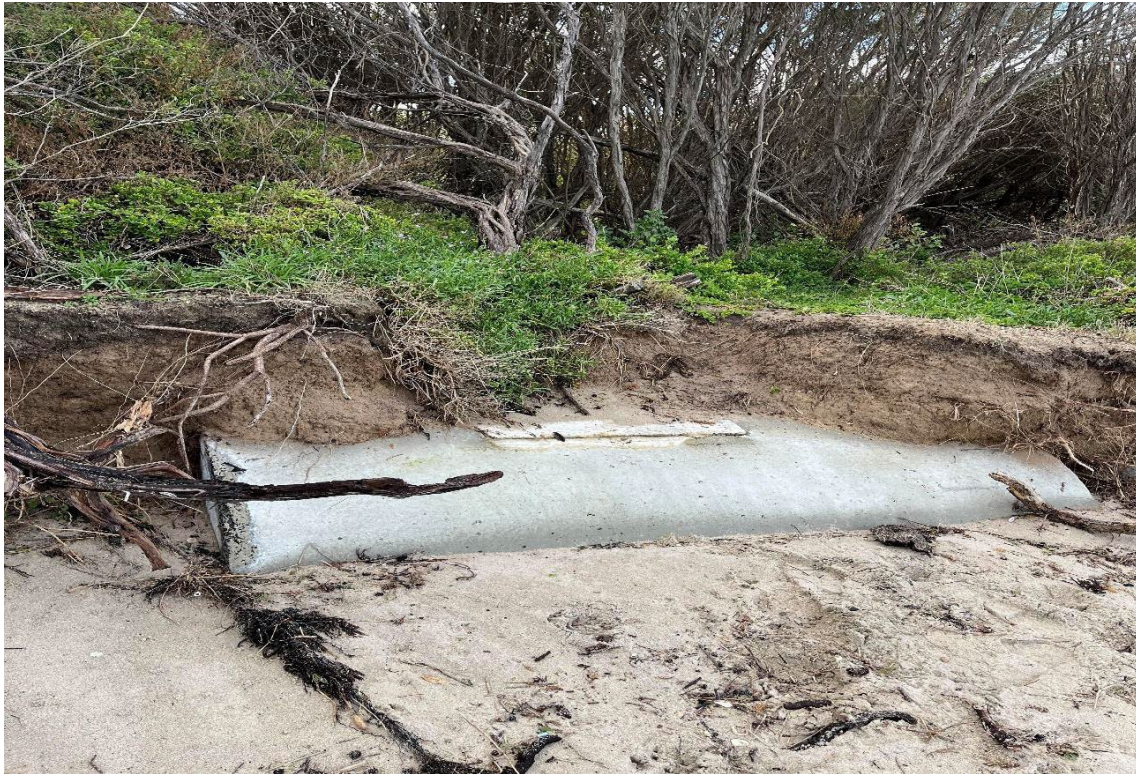
- **Flat Rocks:** Severe erosion of 750 metres of foreshore between the RRV rocks and the escarpment has occurred along the beach known as Flat Rocks. The erosion is evident by the loss of 80-year-old coastal banksias and large cypress trees.
- The remnants of a former camping ground toilet block and its septic tanks have been exposed by the erosion. The toilet block was situated well away from the tidal zone.
- At one point on Cape Paterson Road there is only 10 metres between the erosion and the road. At the boat ramp there is 30 metres. At the present rate the road will be breached within five years.

Caption: The exposed septic tanks at Flat Rocks

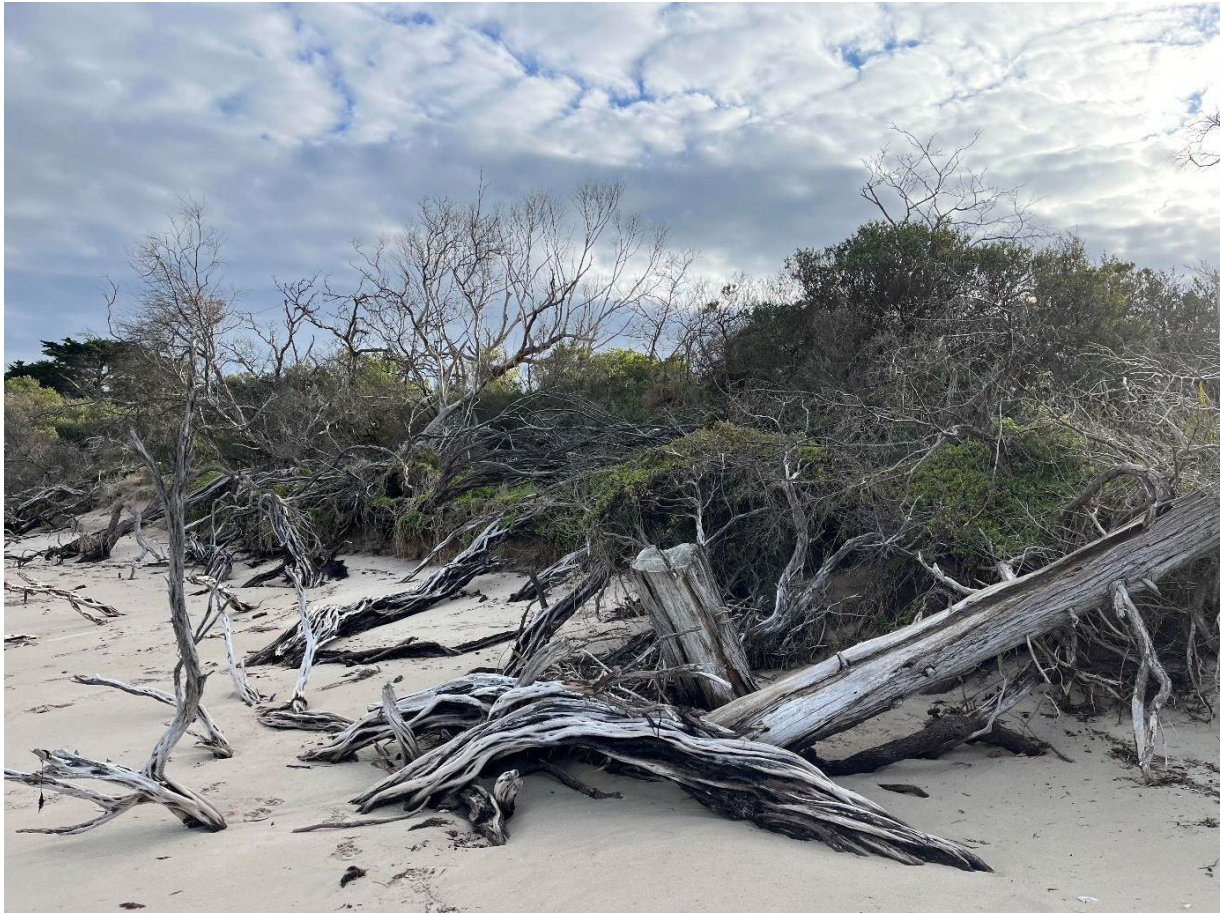
Caption: Unearthed vegetation

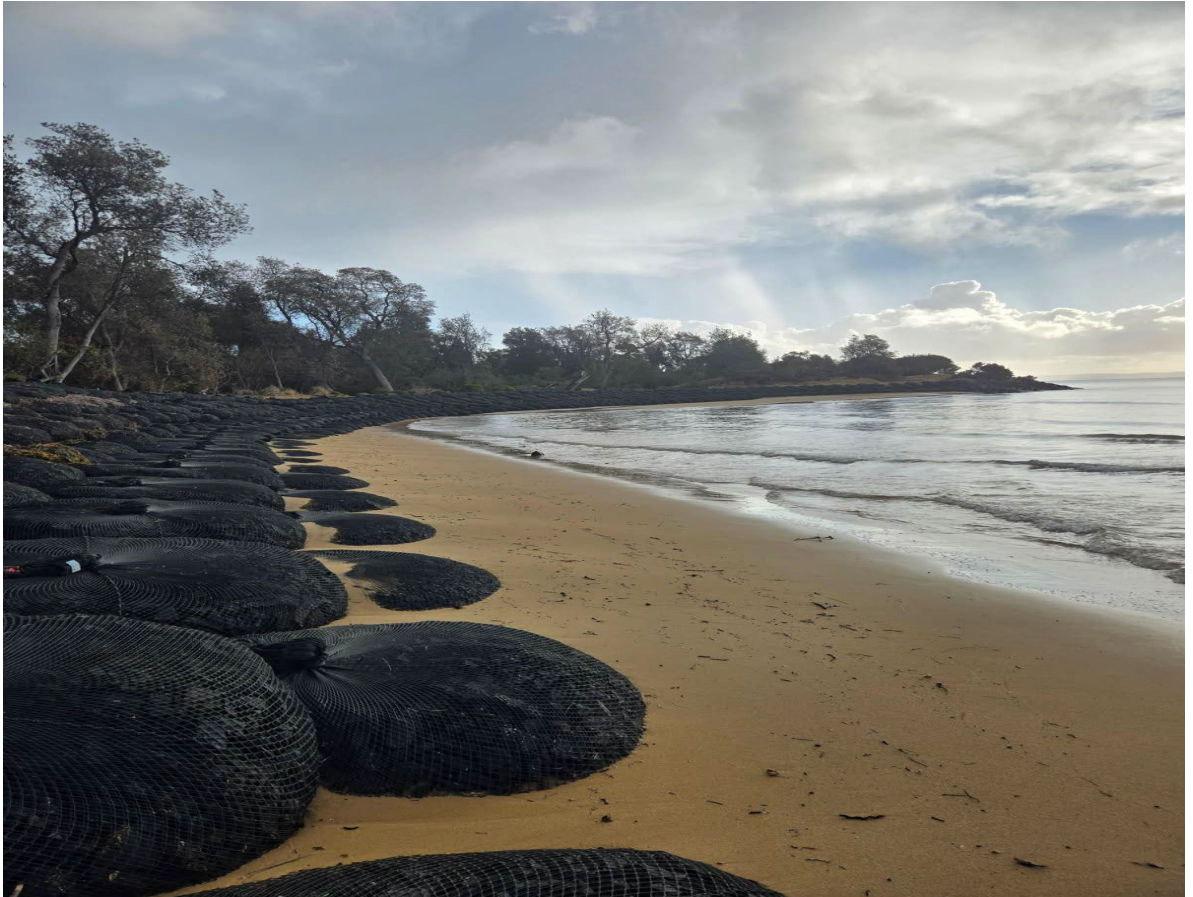
- **Cowes:** Two permanent hard engineered protection works have been constructed in Cowes - a rock revetment complete with stairs and concrete ramp to their beach and a rock bag revetment. Both installations are completely successful with no evidence of causing any loss of the beaches. Inverloch has the same erosion problems as Cowes but is being denied the same treatment. Inverloch has had its SLSC under threat for ten years and no permanent solution has been provided.

Caption: Rock bag revetment at Cowes – Silverleaves.

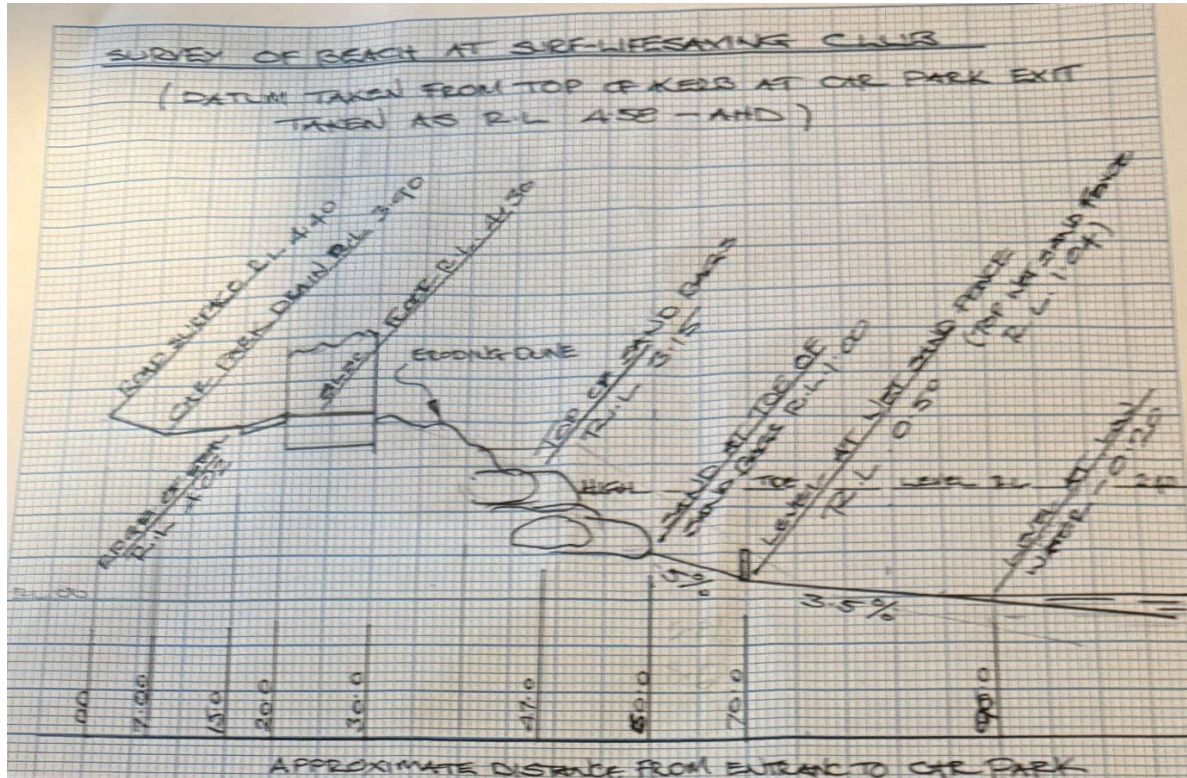
The Clubhouse is currently under severe threat of being lost to erosion. It needs a rock revetment like the RRV installation in either rocks or rock bags constructed on the seaward side of the wet sand 2.0 fence for 150 metres and to a height of RL 3.6. AHD.

A plan shown below drawn from surveyed levels illustrates the need for the revetment.

Installation of the revetment would require a concrete ramp like that at Cowes Silverleaves to provide beach access for foot and lifesaving vehicles.

Topping up the eroded ends of the sandbags overnight is extremely expensive and futile. A rock revetment is the only possible method to save the clubhouse and must be implemented without any further procrastination. Without question it should be the priority for the use of the \$ 3.3 M Federal Government grant. Wasting the funds on a pumped dune renourishment program instead of saving the clubhouse would be unforgivable.
